NEWSC Filtration Systems Workshop

Biofilter Case Studies City of Appleton

December 06, 2018

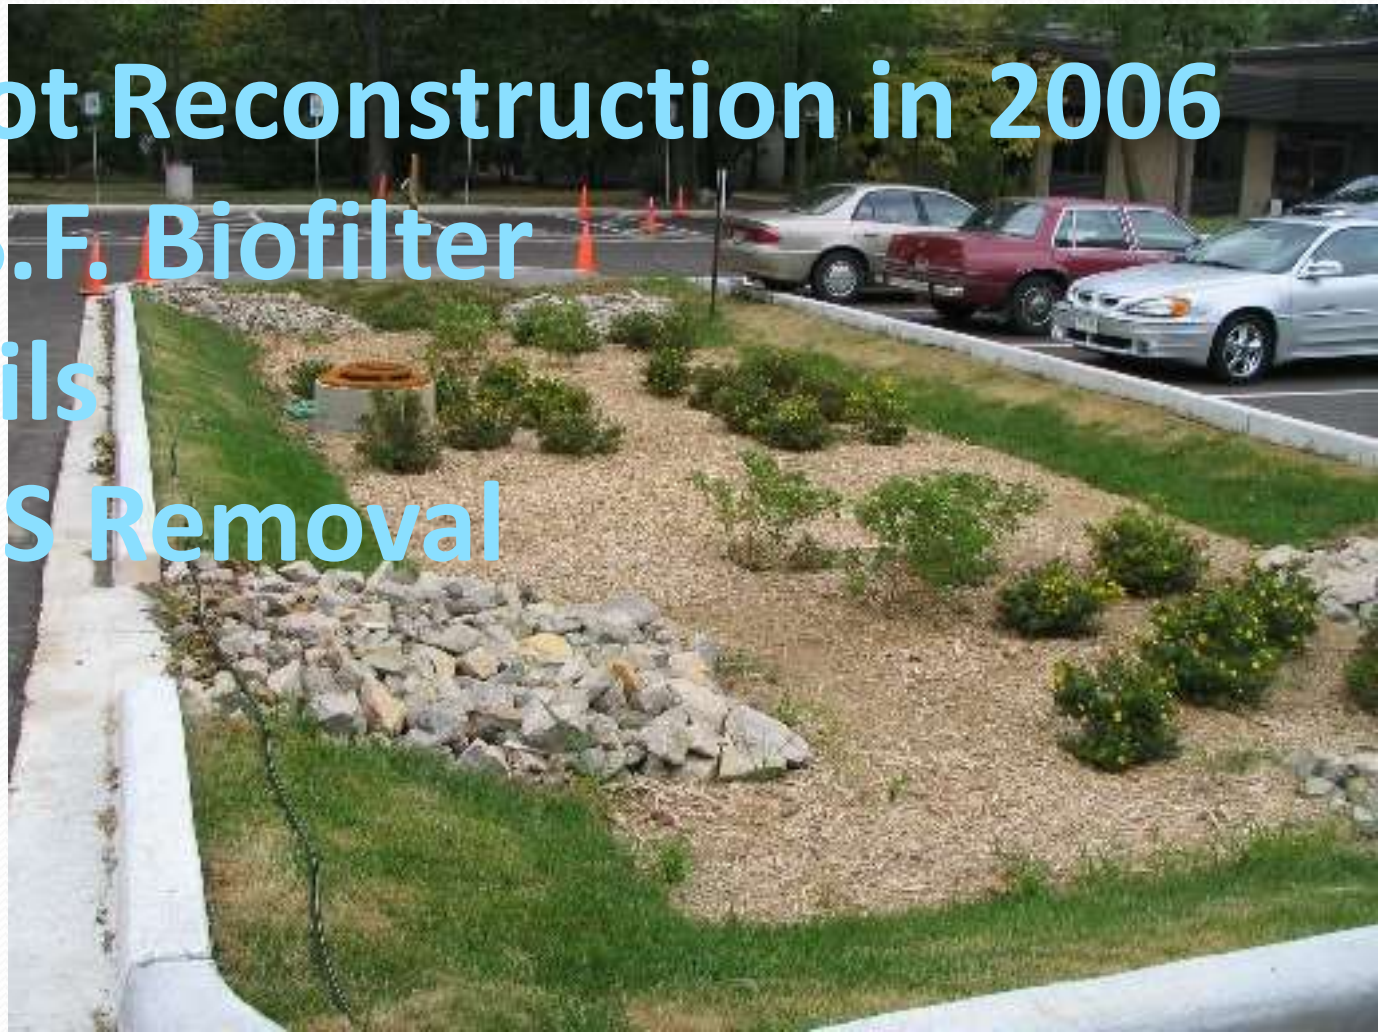
- 1,500 S.F. Biofilter
- Clay soils
- 40% TSS Removal

After Initial Construction 2006

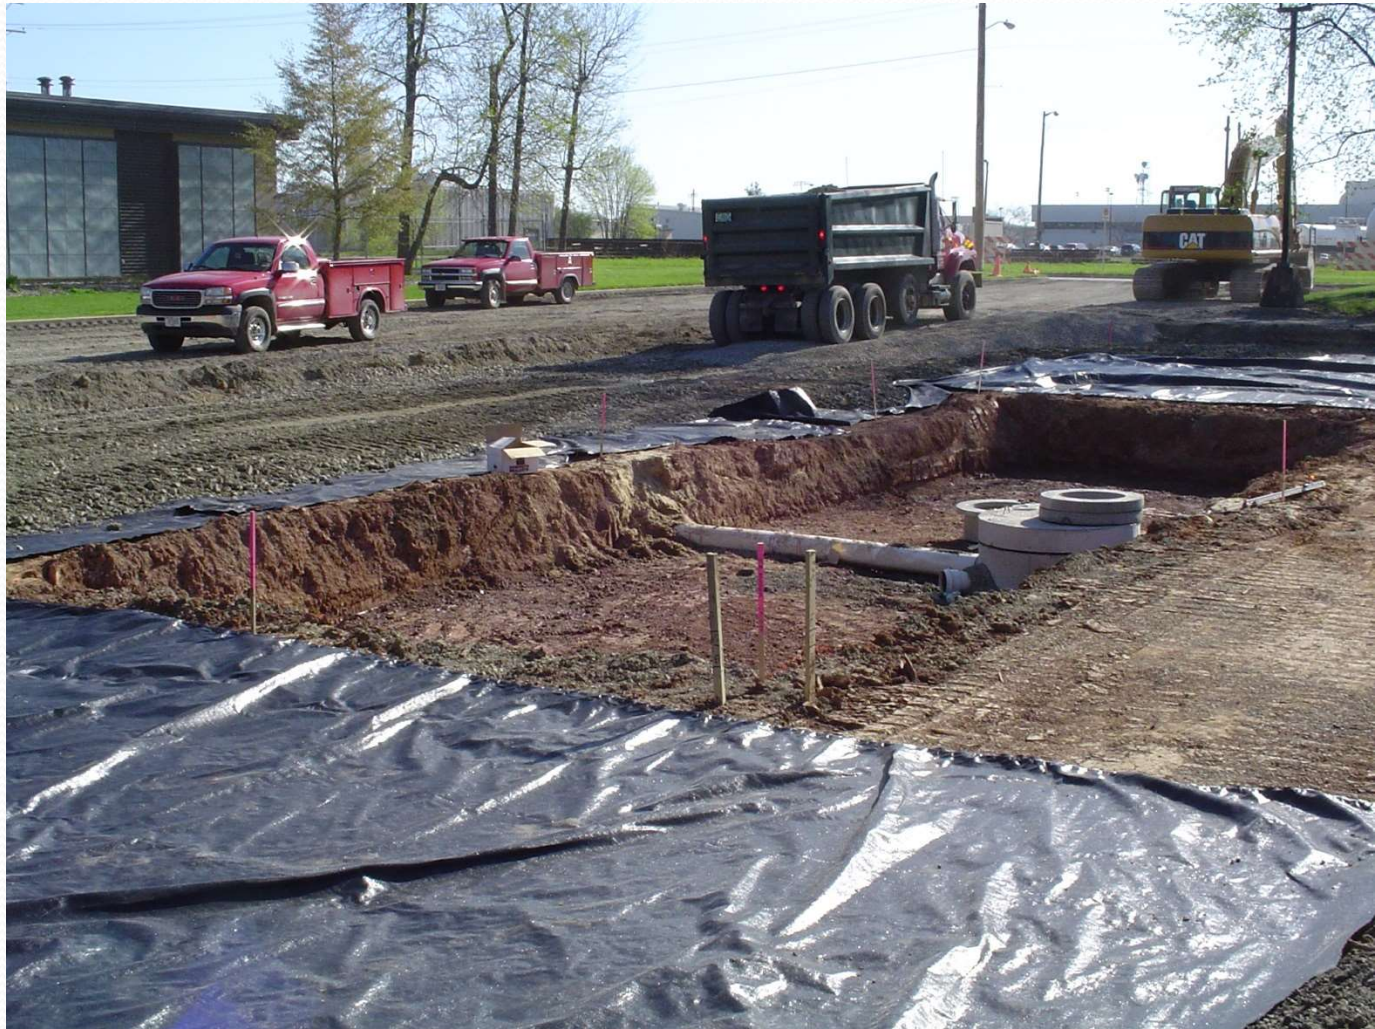
During Construction 2006

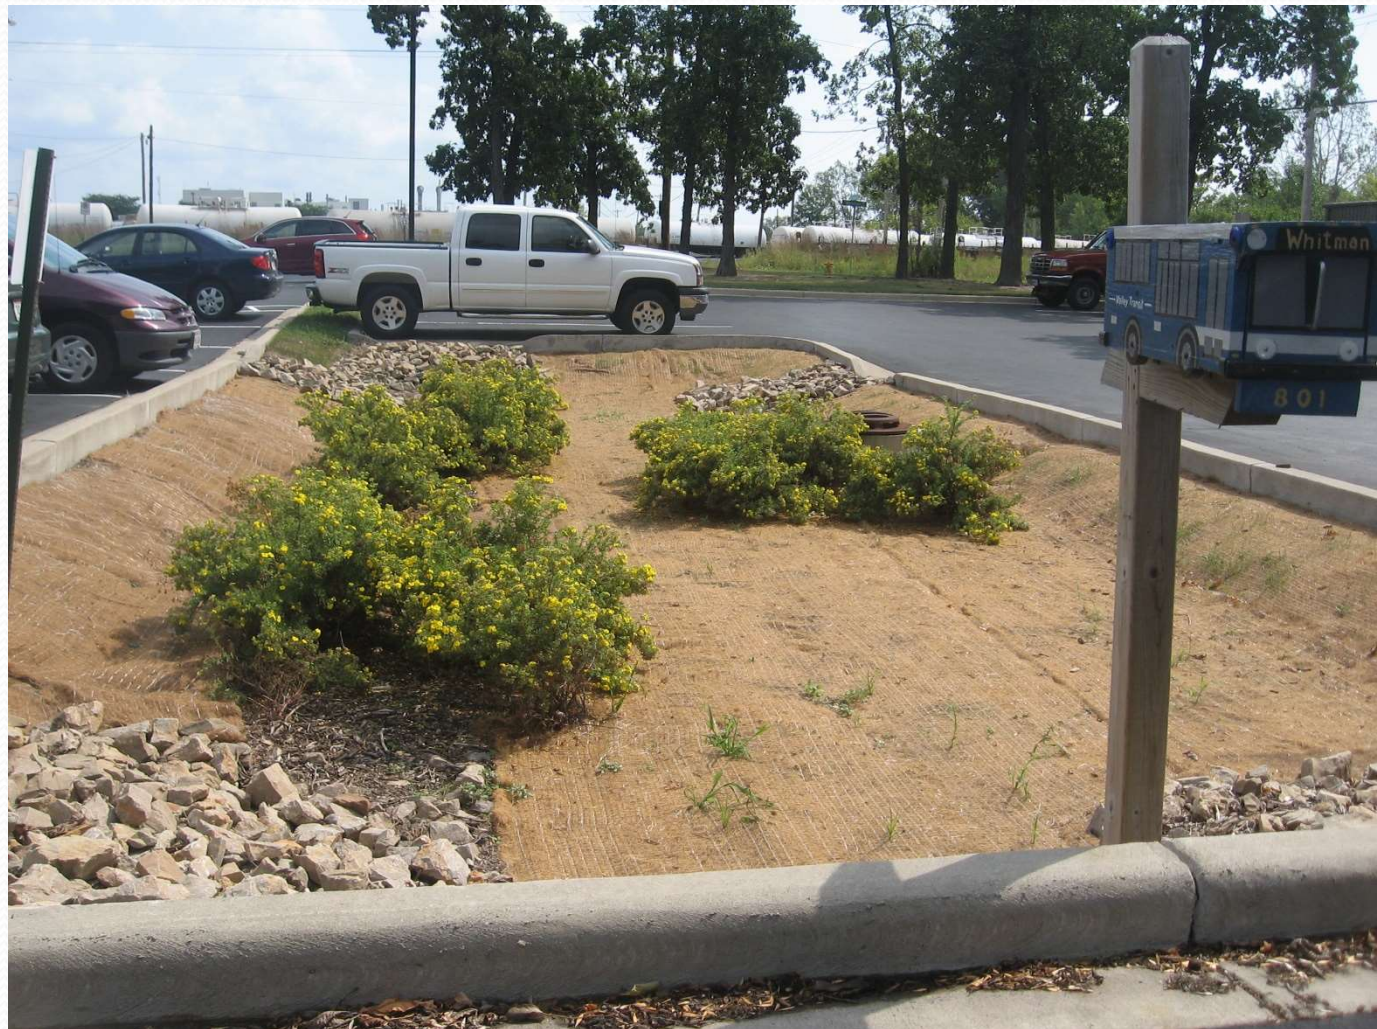
Coconut Mat Placed in 2011

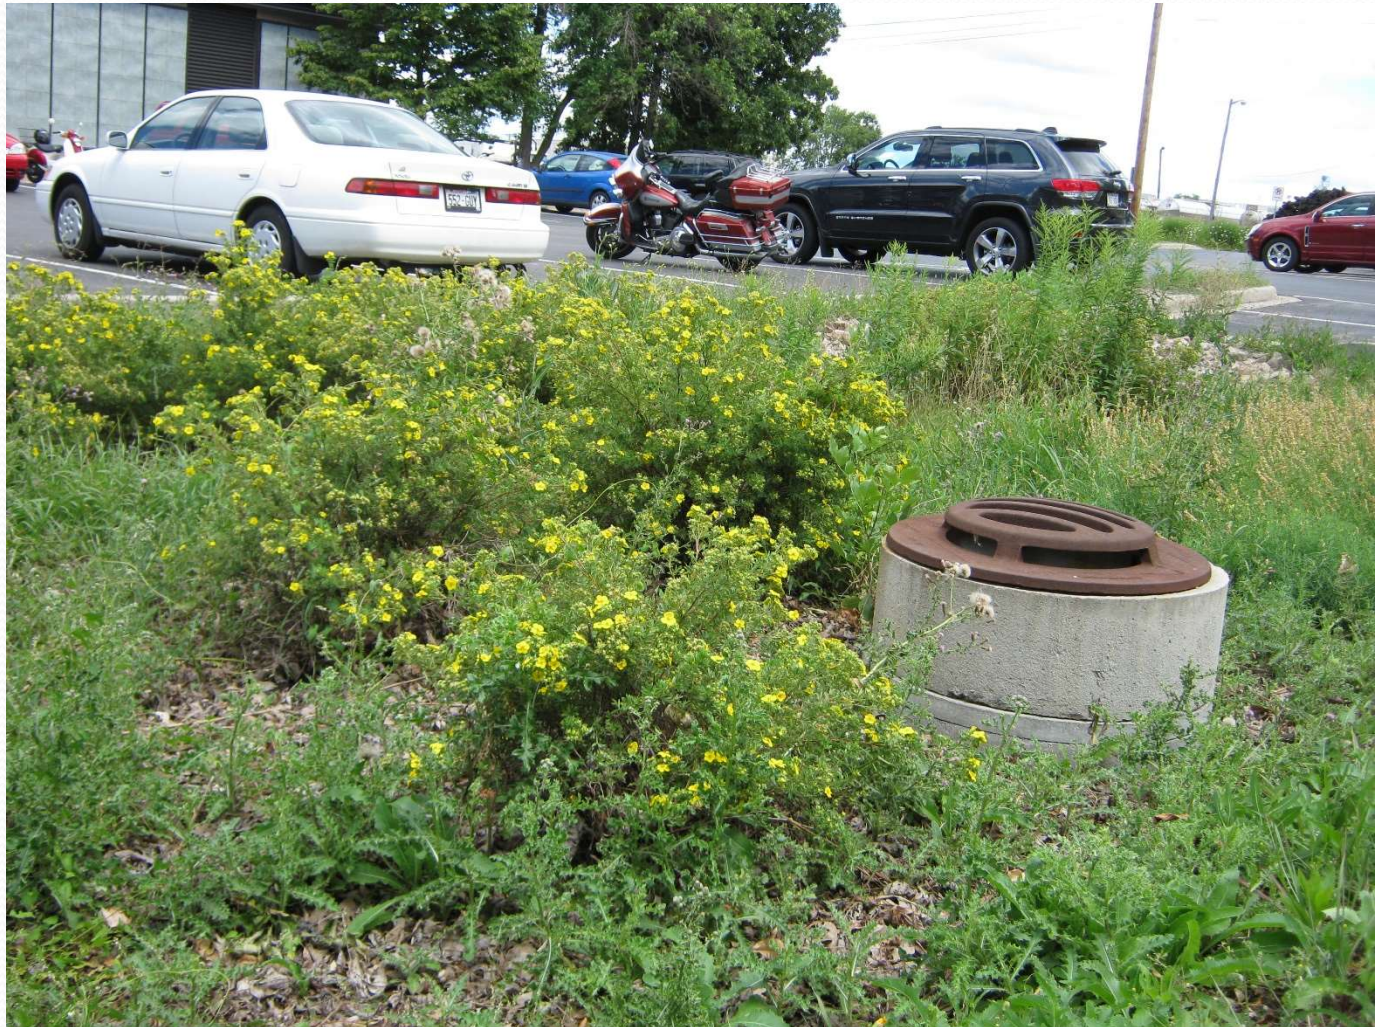
Weeds taking over by 2015

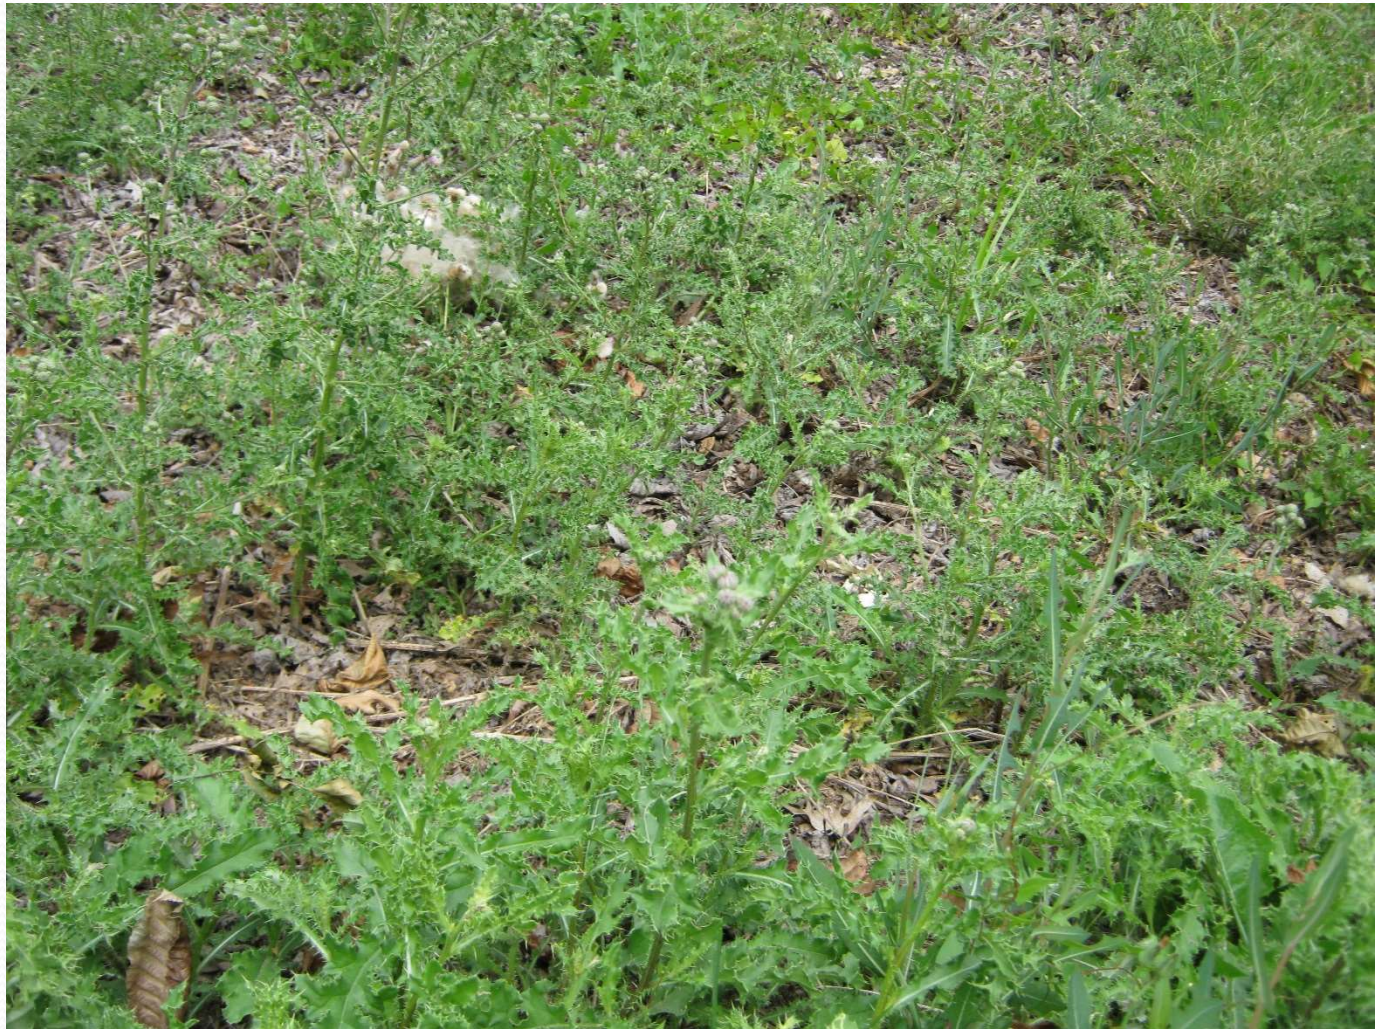
Weeds taking over by 2015

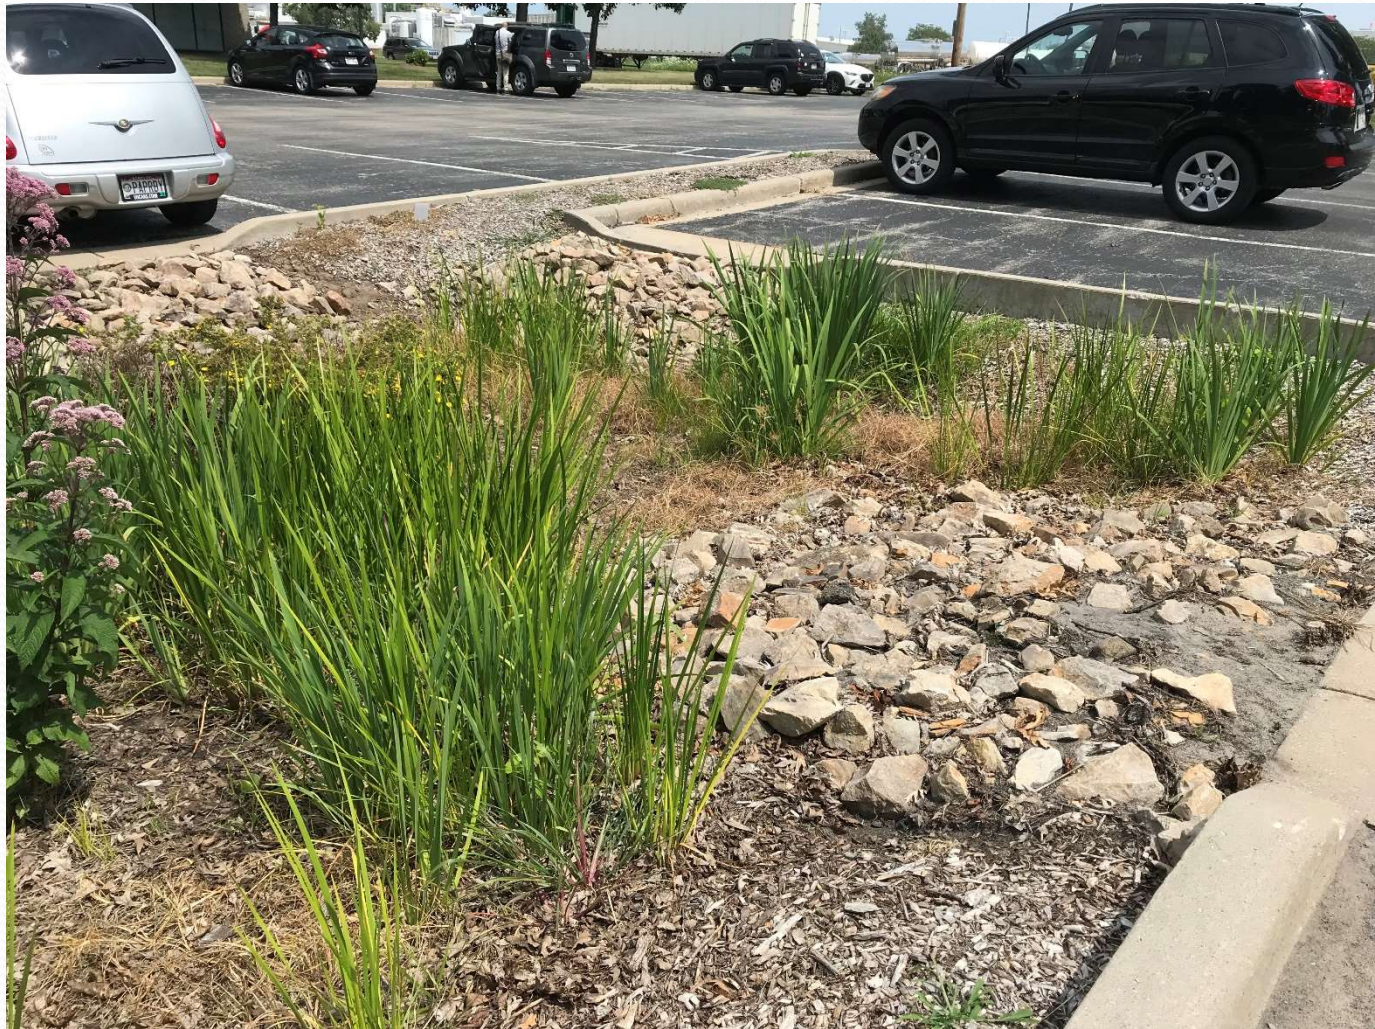
2018 (Supplemental plantings in 2016)

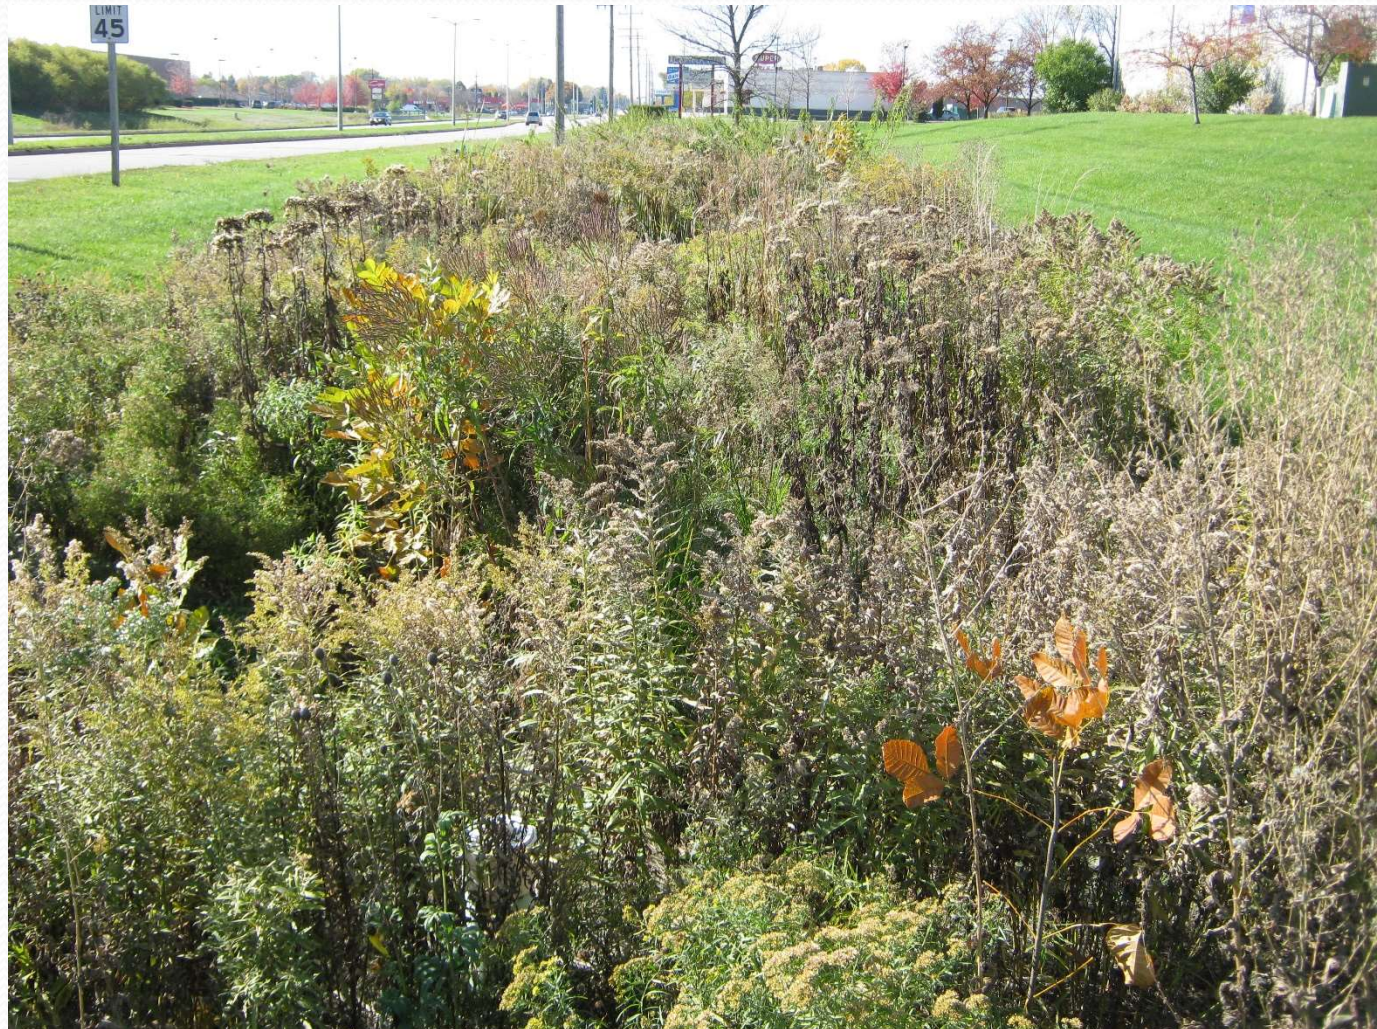
2014 Photo. Initial Planting 2009

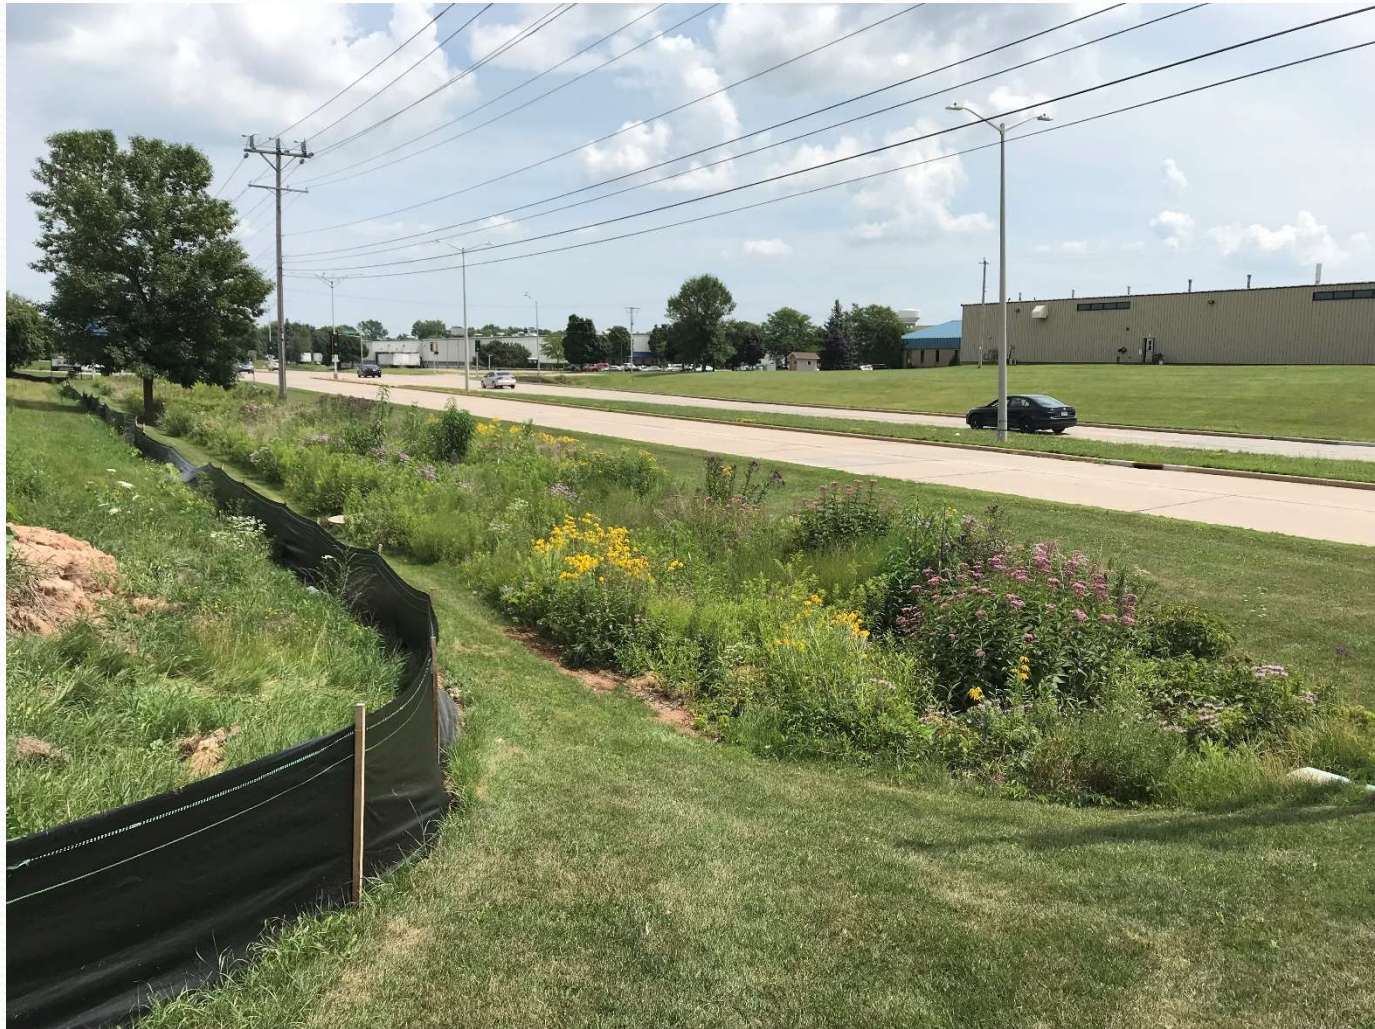
2018 Photo with sediment discharge

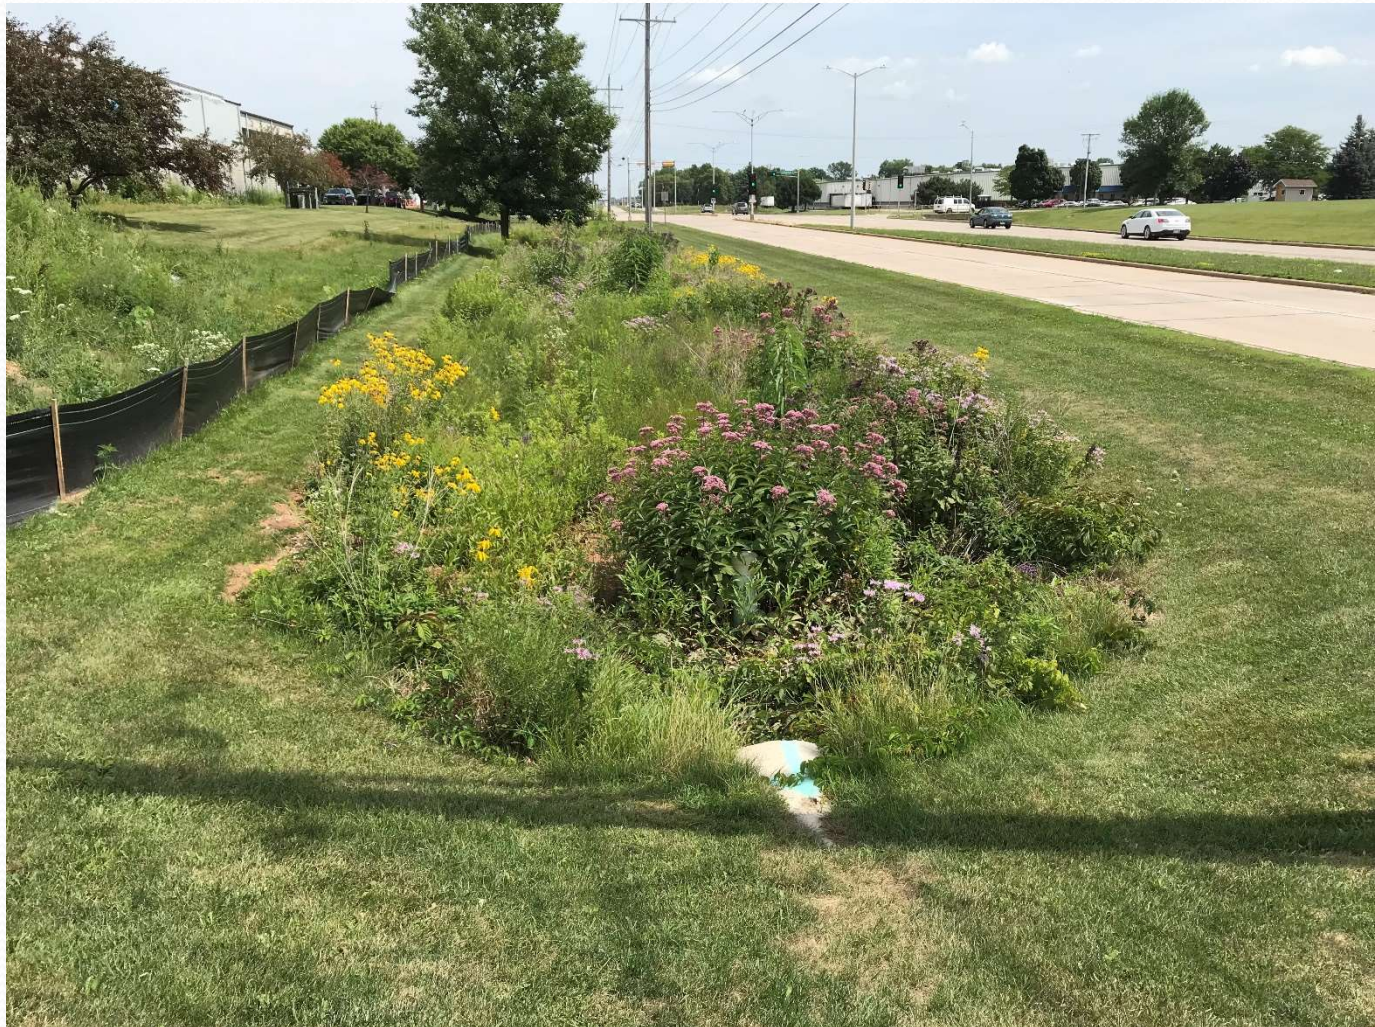
2018 Photo with sediment discharge

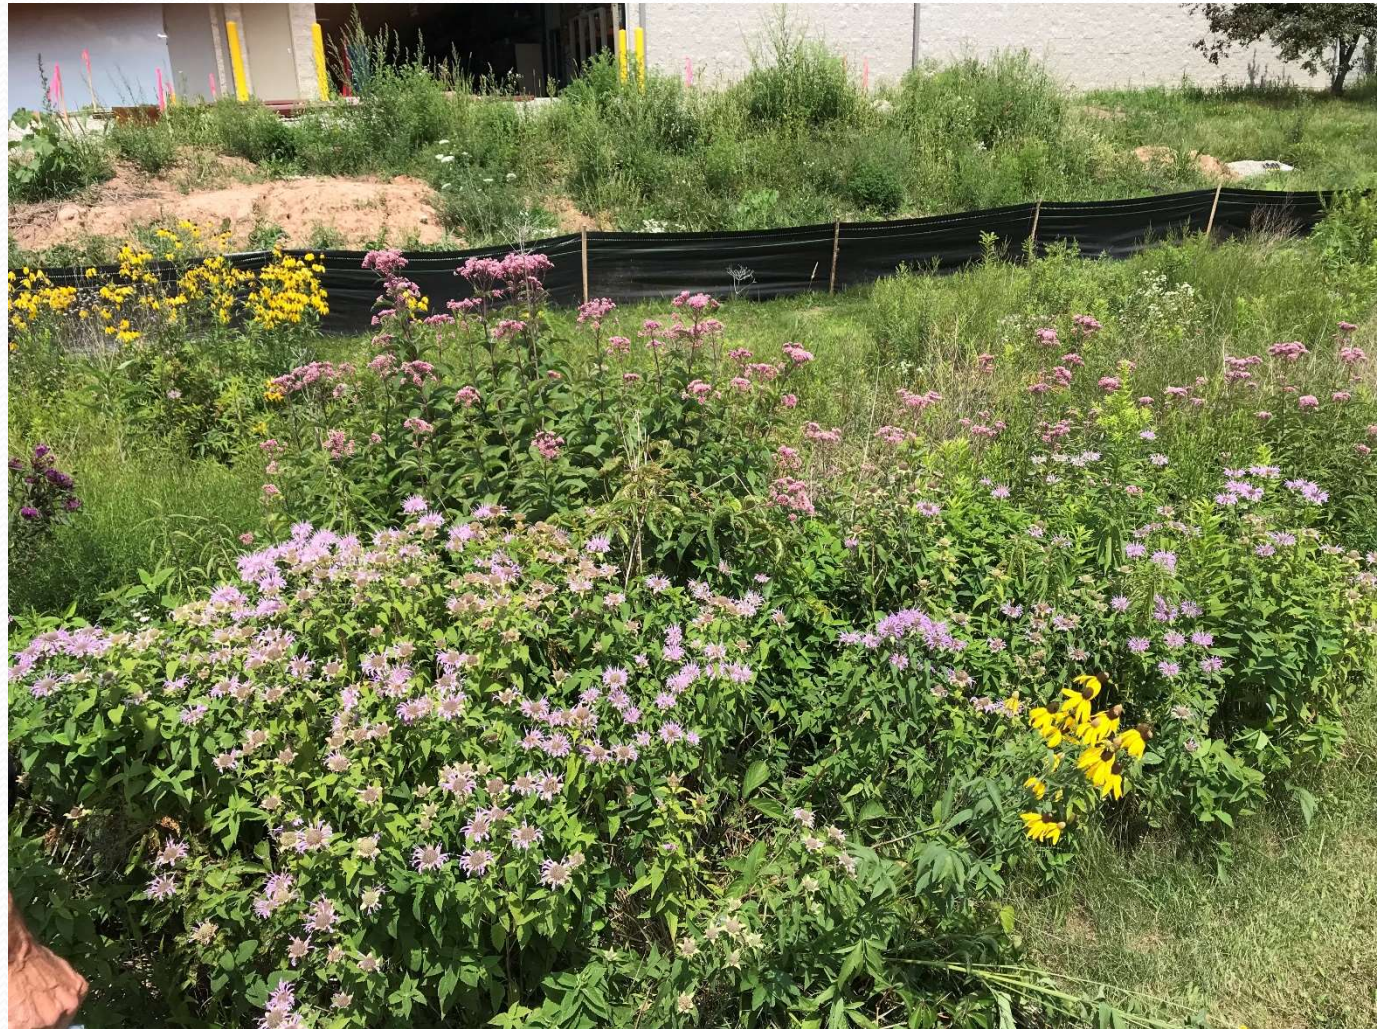
2018 Photo with sediment discharge

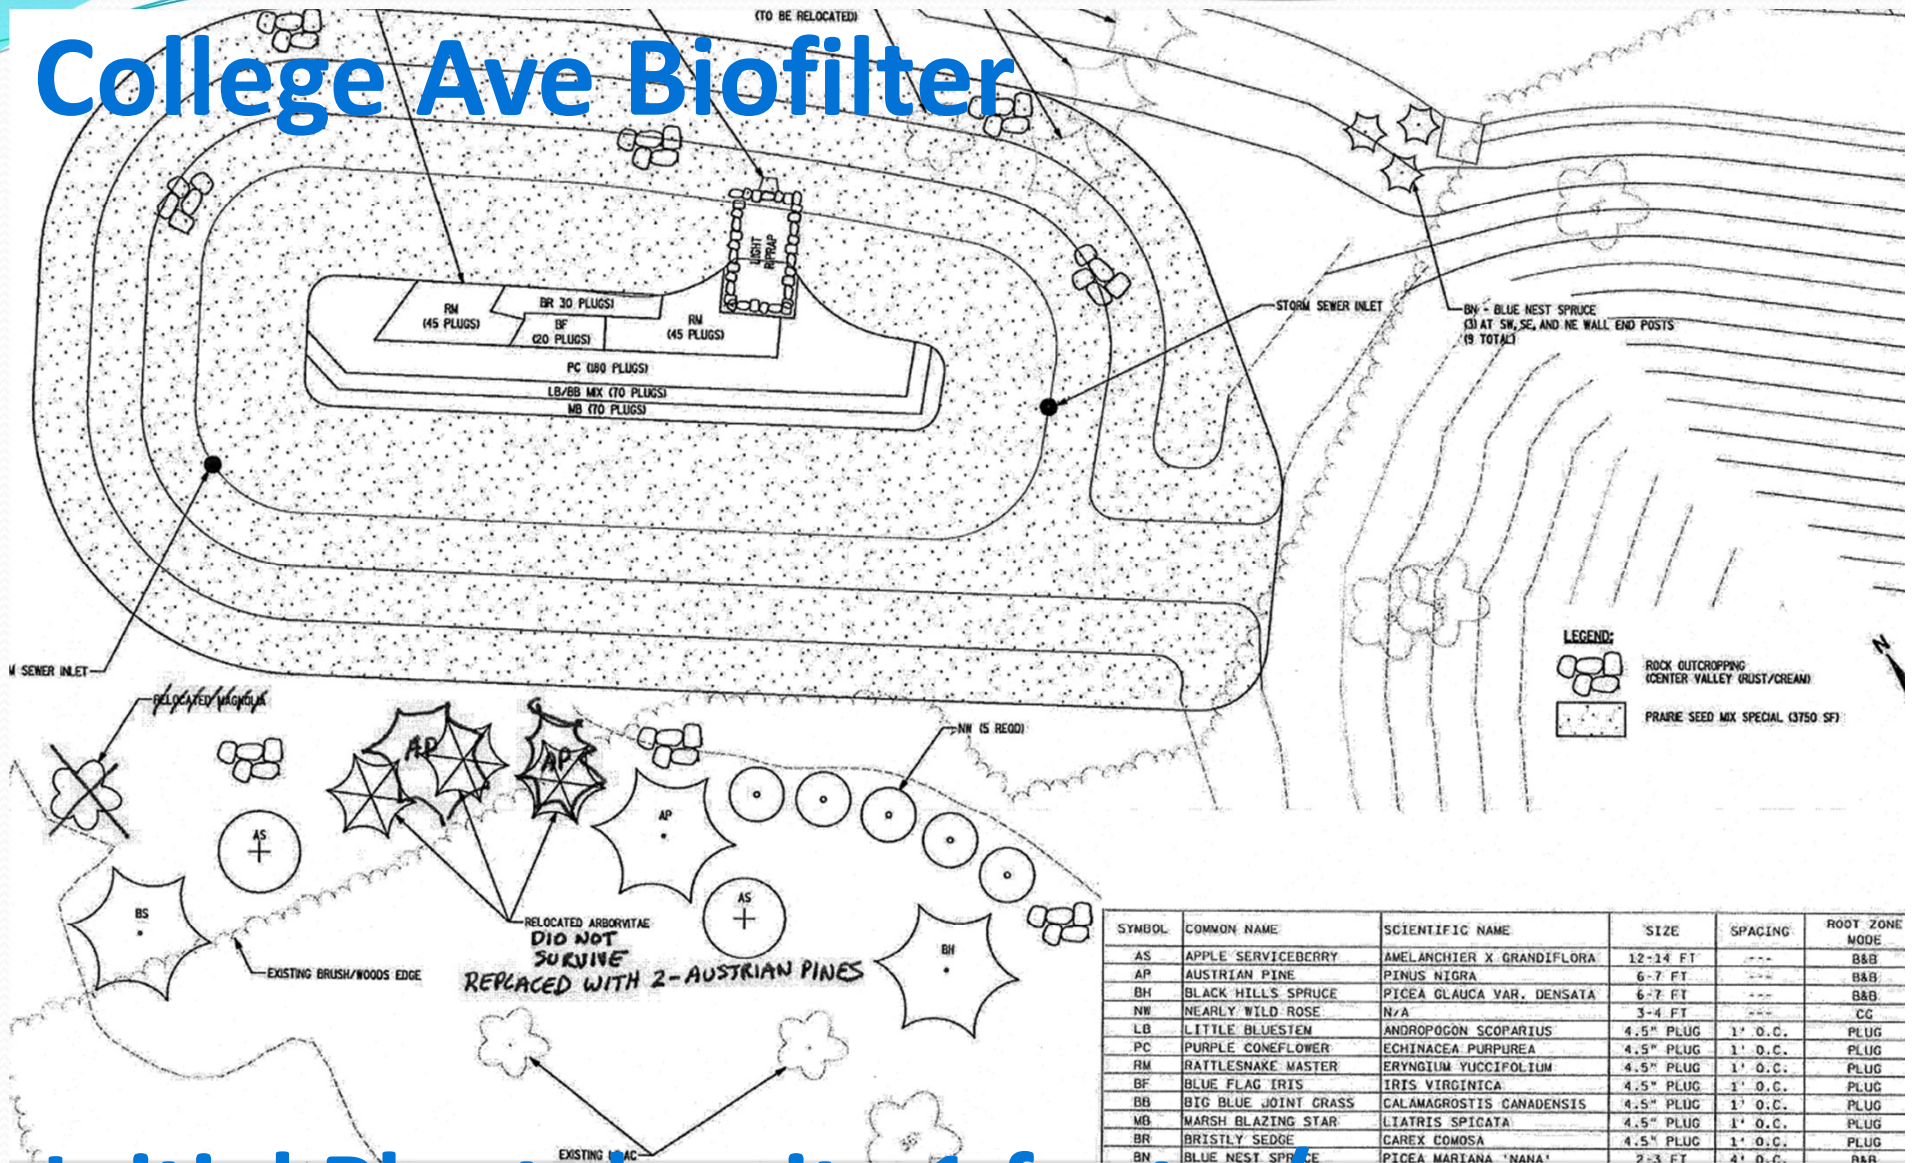
Initial Plant density 1 foot o/c

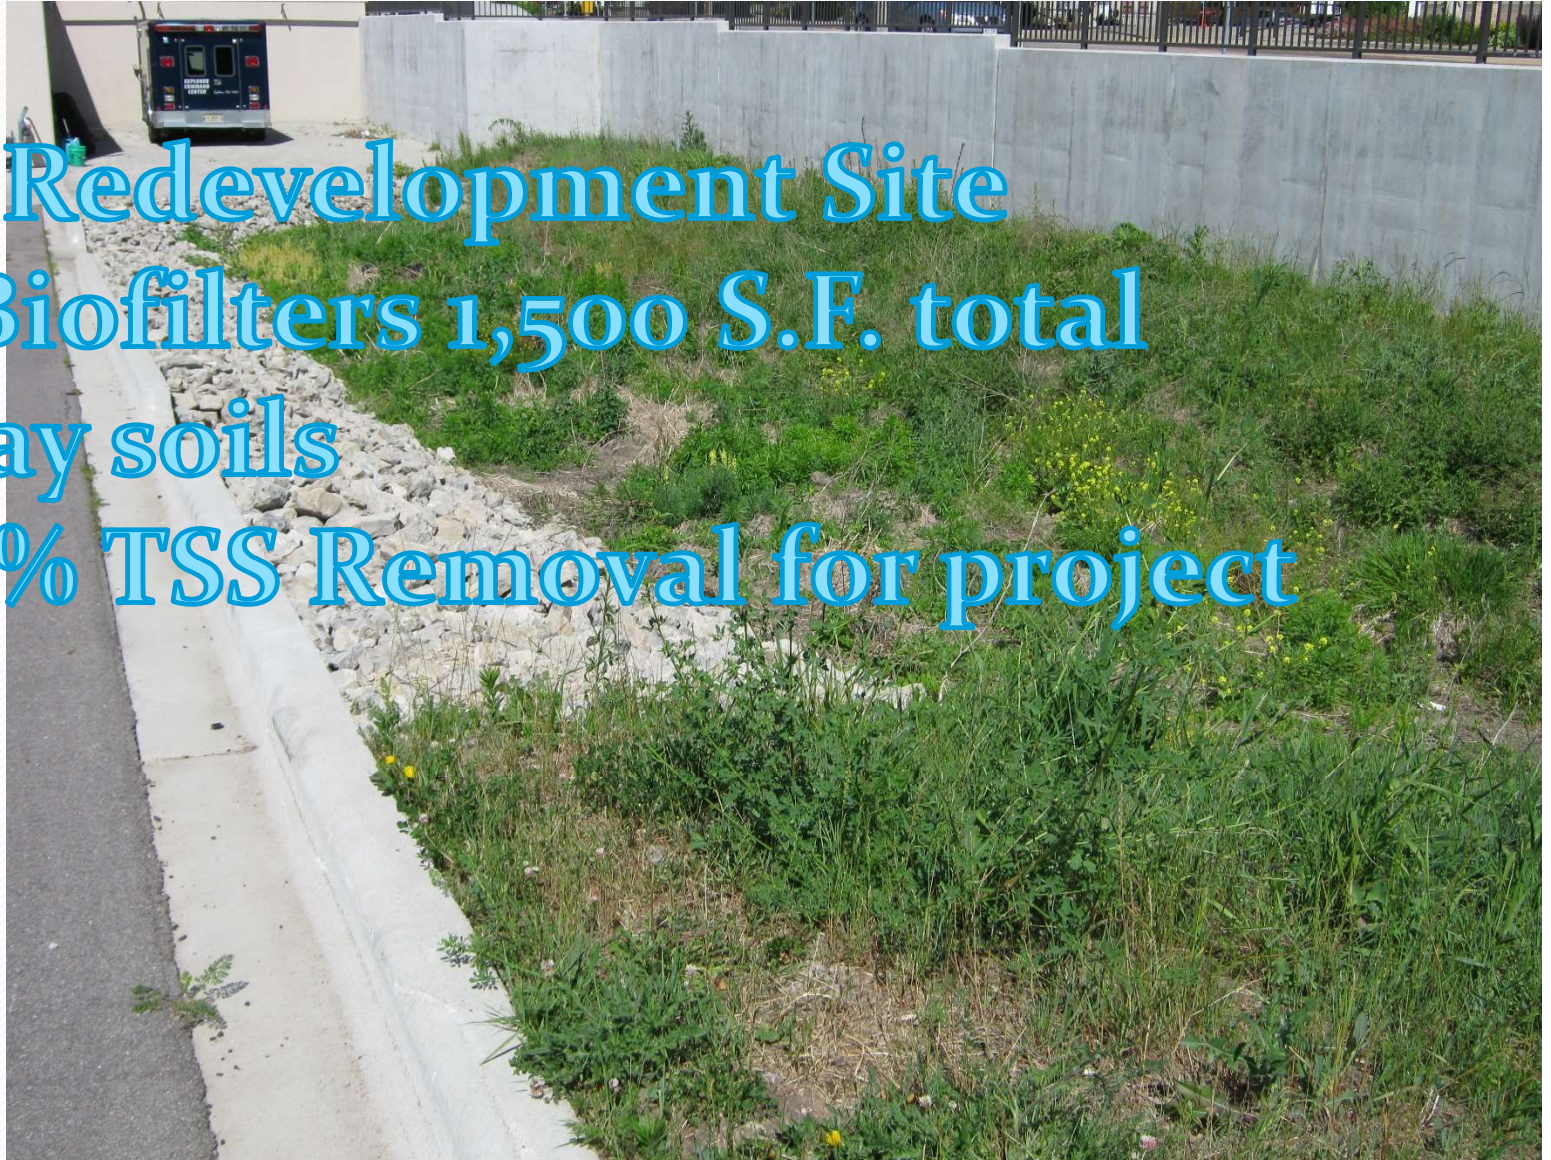
2012

APD Redevelopment Site

- 2 Biofilters 1,500 S.F. total
- Clay soils
- 40% TSS Removal for project

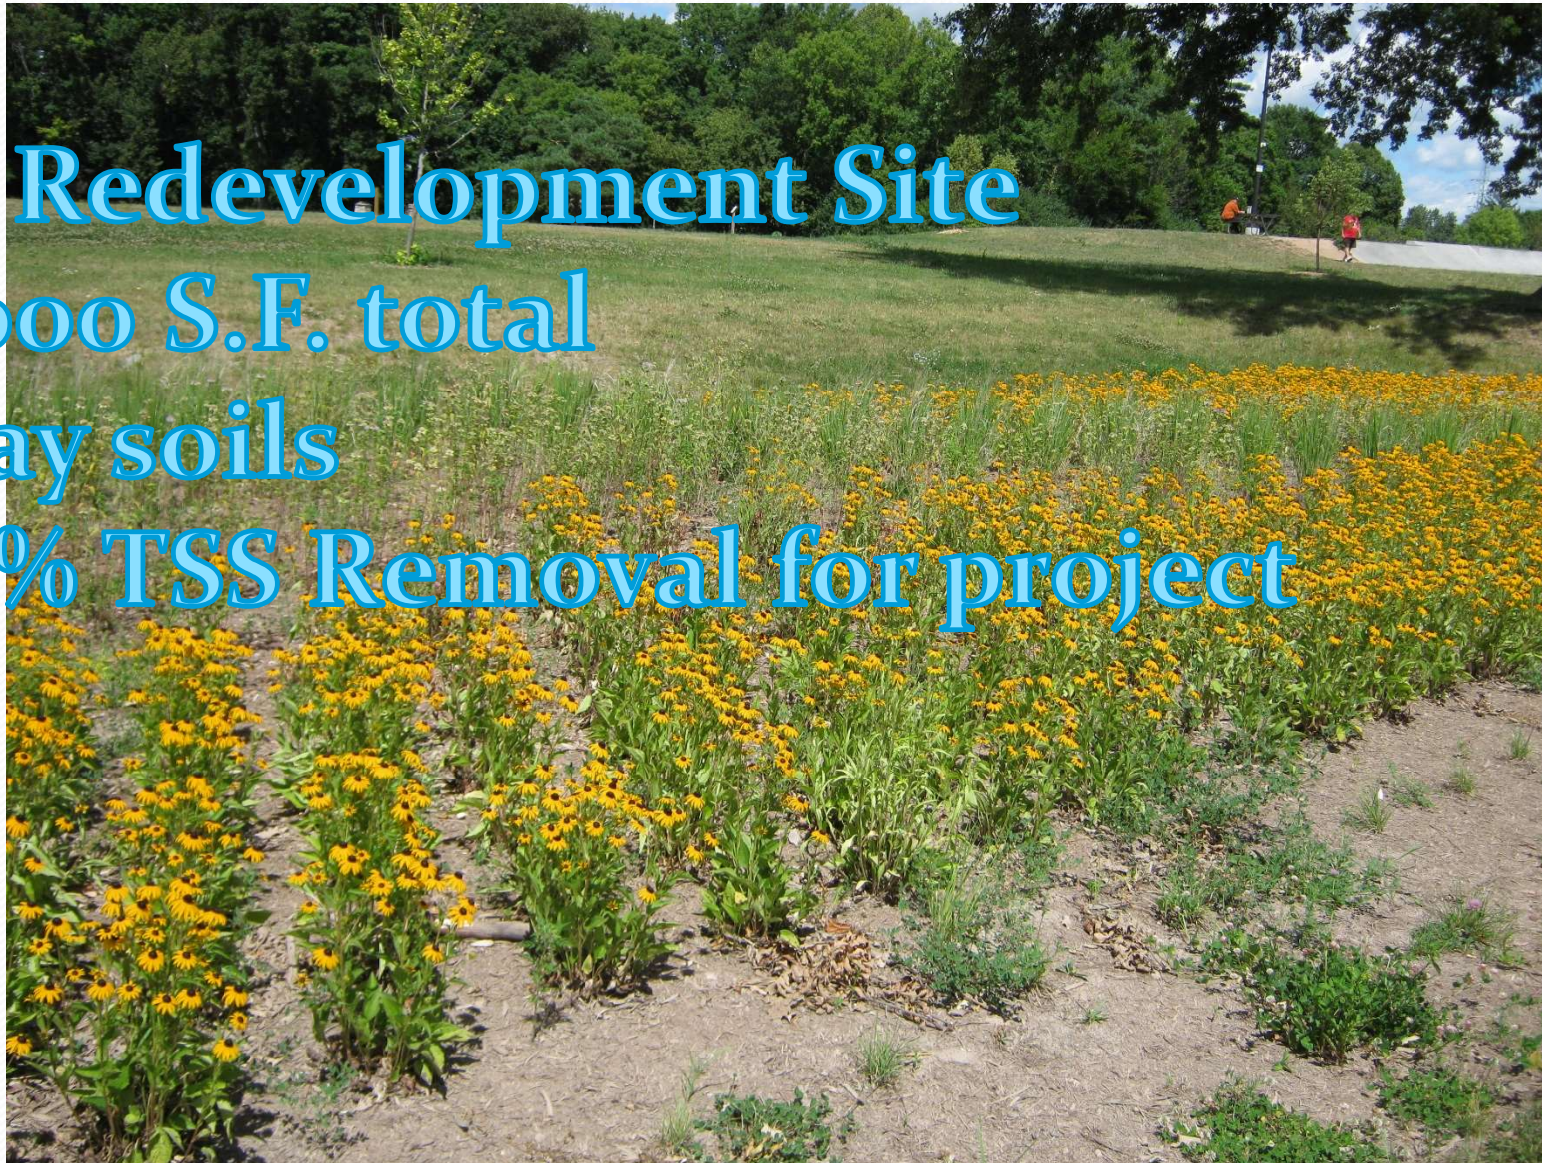
2015

Park Redevelopment Site

- 3,000 S.F. total
- Clay soils
- 40% TSS Removal for project
